Case History 40629: Gutters - Demo - Columbus, Ohio 29-JUNE-2004
Precision Adjusting Gutters on Limberlost Court

The following is an example of “Fine Tuning” or “Precision Adjusting” a residential Gutter where the cost for the adjustment is a mere fraction of the cost for removal and replacement of the entire gutter system. Even if the Gutter were completely re-poured, the slope for this particular residential street was so slight as to make it likely that the problem would continue to exist even with a newly poured Gutter.

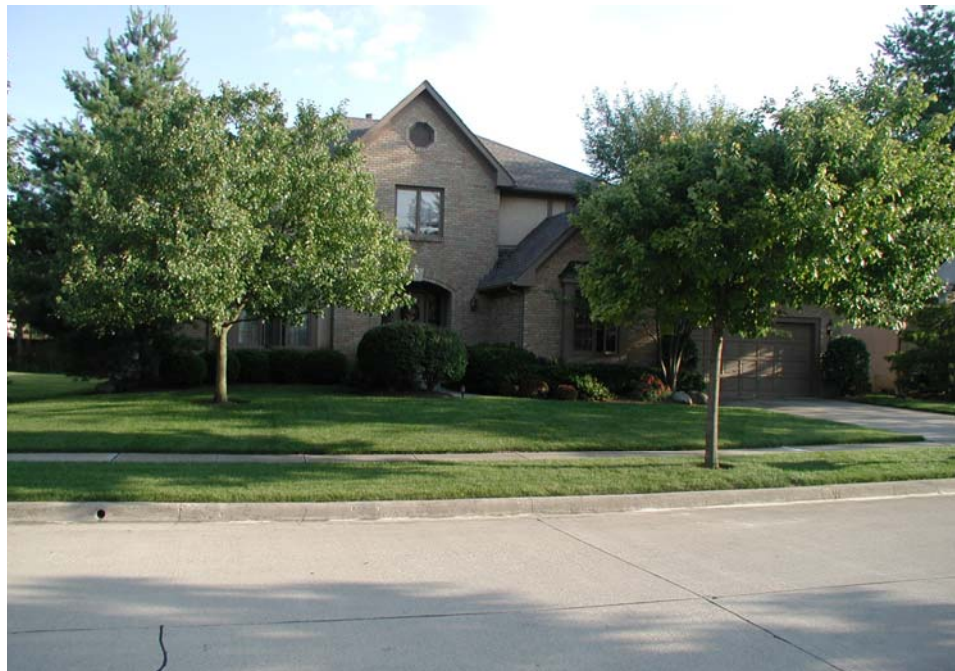
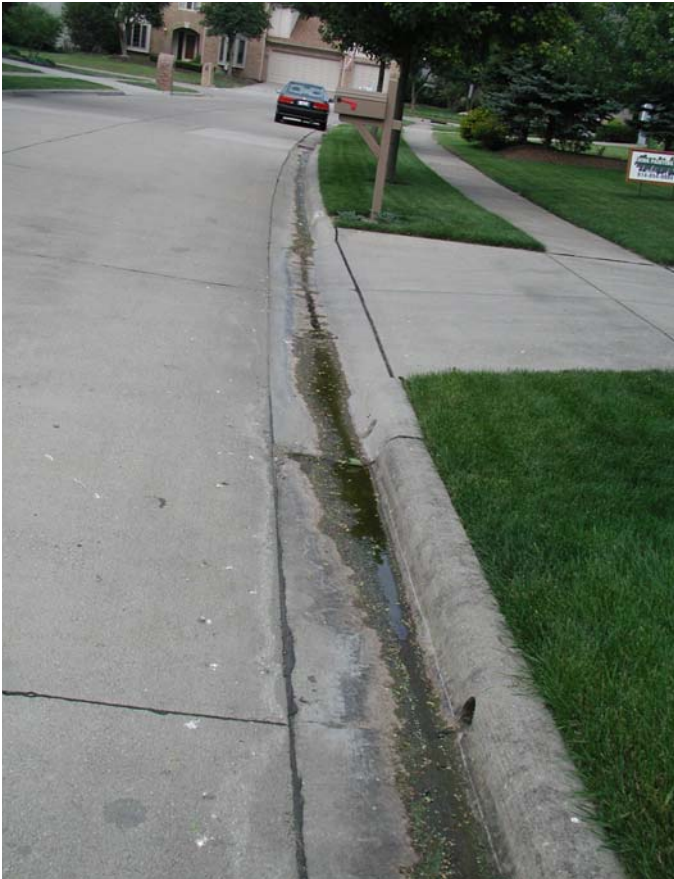
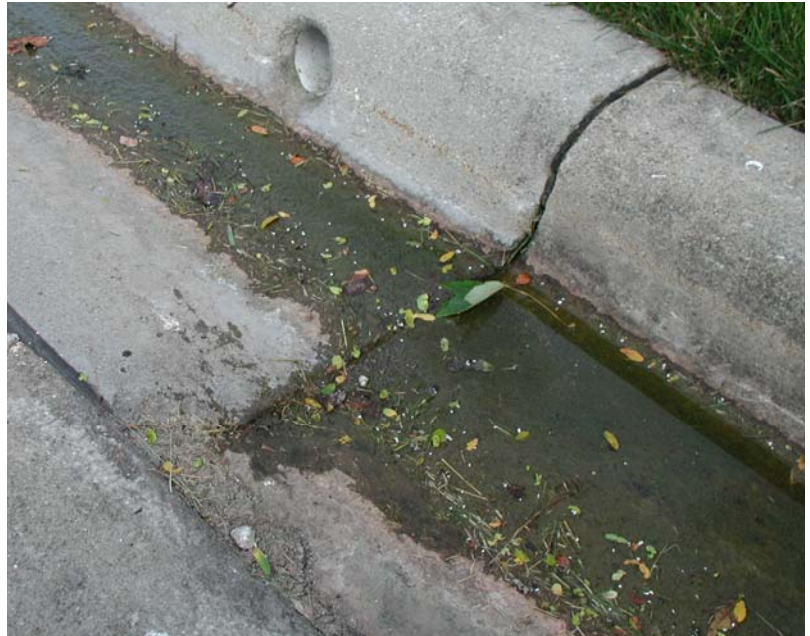
The overall view of the home on Limberlost (After Grinding) shows that this is certainly not a problem with an older decaying neighborhood. No indeed, this was clearly a problem of ponding in the gutters as caused by the irregularities in the “as poured” surface of the relatively new concrete gutters.

The Following pictures show the gutters prior to grinding. The Ponding is due to unevenly poured concrete.

Ponding in Gutters due to uneven Concrete.

PRE-TREATMENT & MEASUREMENT: Prior to the actual Demonstration, it was necessary to build a temporary Dam on the gutter to allow the site to be cleaned and dried . The Level and Markers were then used to identify and mark the high spots along the length of the Gutter so that grinding could proceed smoothly once the demonstration started.

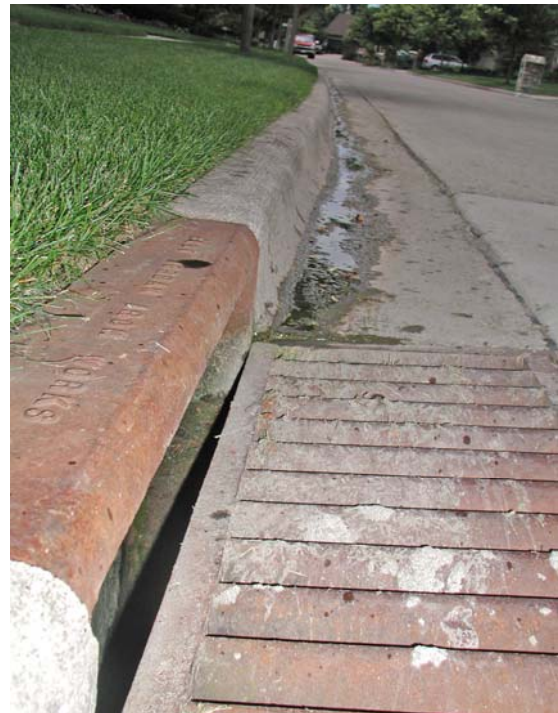
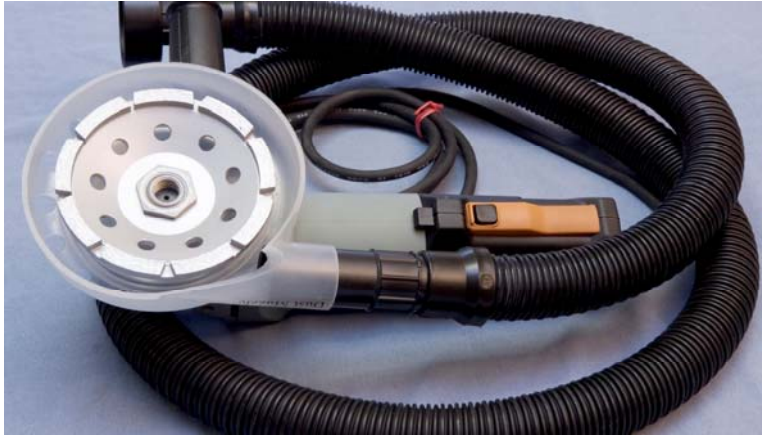
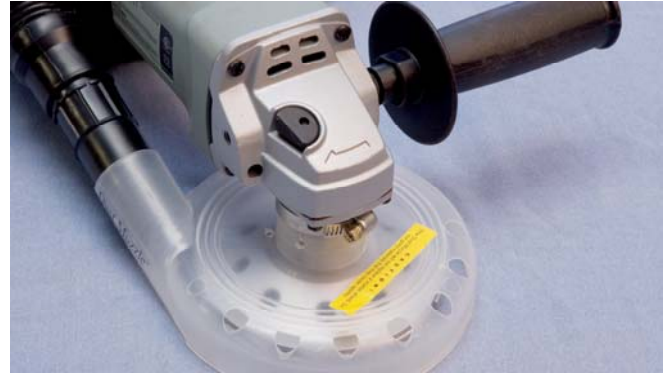
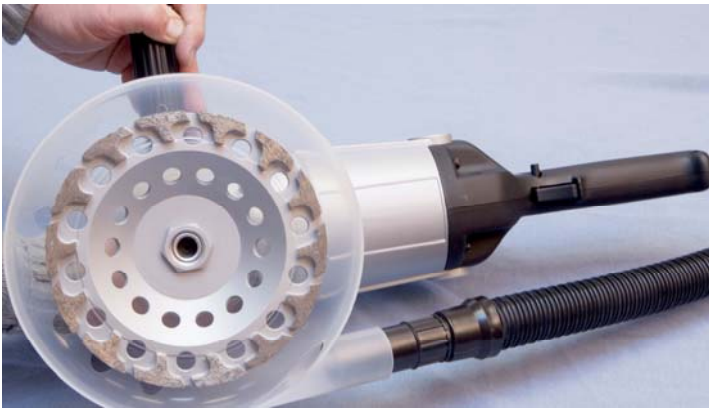
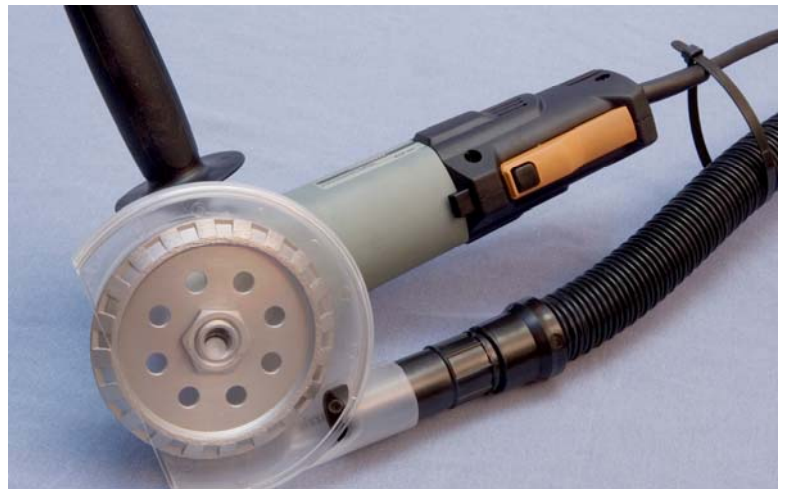
The TOOLS: The Tools included a Jepson 7” Grinder equipped with a single row Diamond Cup for higher removal rates, a 4.5” Jepson Grinder equipped with a single row diamond cup for fine tuning the edges, and a third grinder which was equipped with a Crack Sealer Wheel that would eventually come in handy for grinding a V-notch in the Iron Sewer to permit proper drainage. Each Grinder was equipped with a Dust Muzzle to collect the dust at the point of origin and feed it through a hose to a Loveless-Ash Fine Particle Vacuum System.

The Diamond Cups as well as the flexible dust containment system, the Dust Muzzle, are shown in the adjacent photographs.

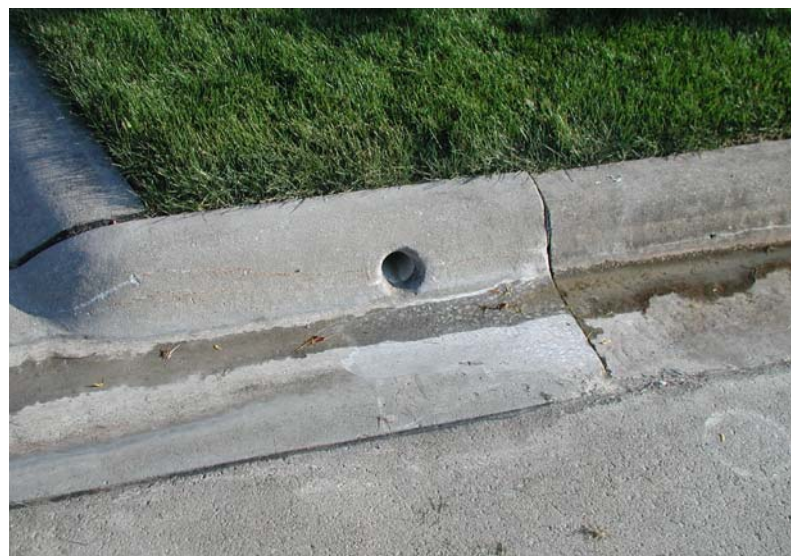
The High section at the right edge of the property has been ground down to eliminate the ponding as is seen in the adjacent photograph where the water flow has been reduced to a uniform stream.

The Main Length of the gutter shows the series of Bumps which have been smoothed as well as the adjustments to the gutter/curb junction to eliminate the water ponds. The resultant surface is as strong or stronger than the original surface

since the grinder can easily grind through the stone aggregate where necessary. This particular characteristic of the stone aggregate is best seen later in this report where the actual Sidewalk Grinding was done for the home owner who had been so nice as to allow us to use her house for our Demonstration..

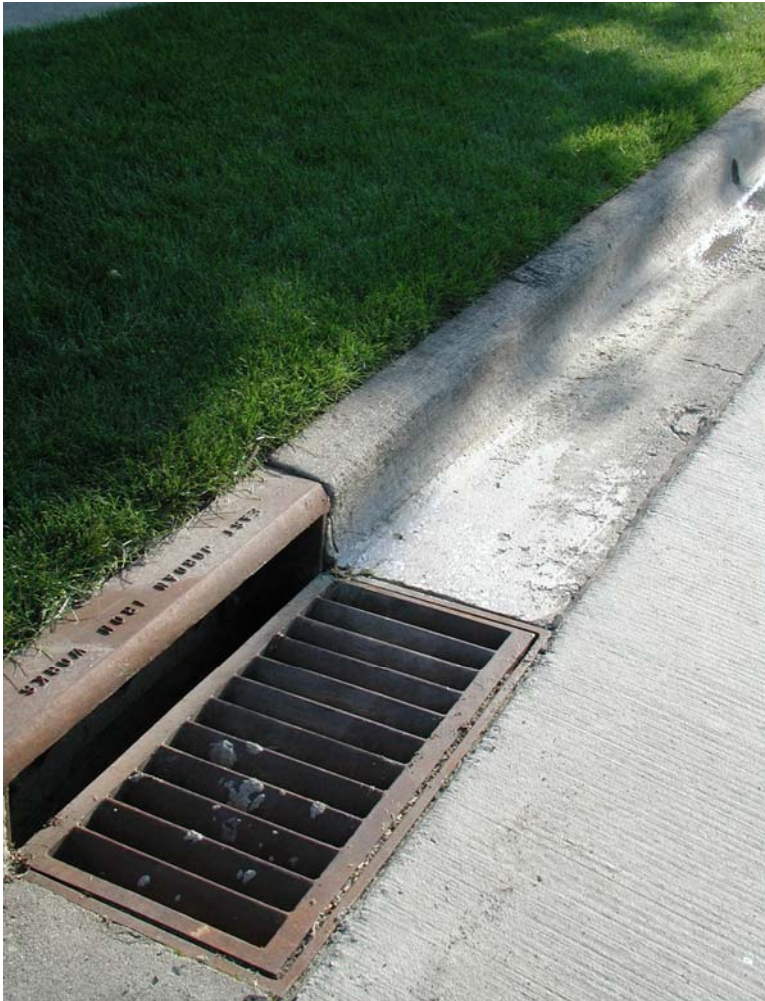
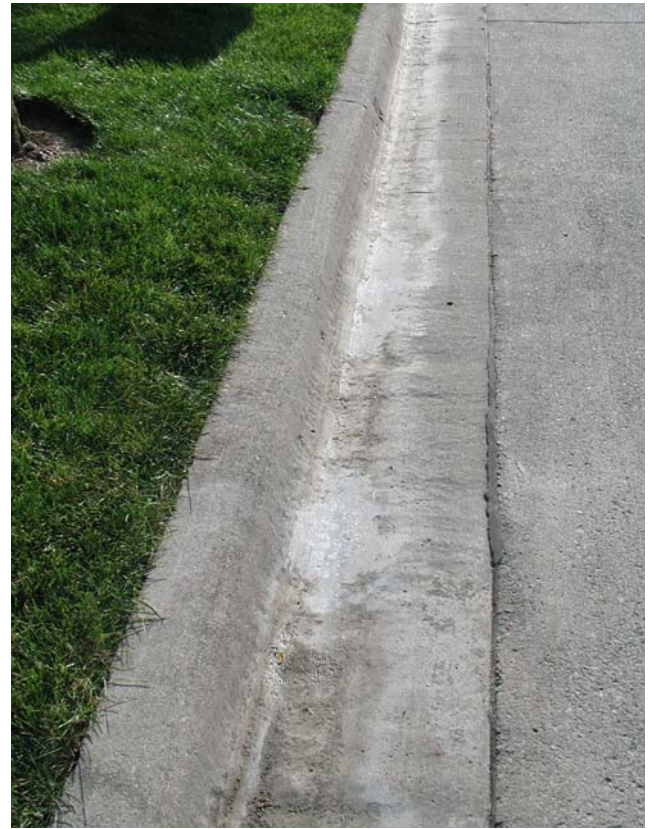
The overall appearance of the home and the neighborhood was enhanced by the relatively simple concrete grinding process, using tools and equipment that is well within the reach of the typical homeowner or can be rented from the local hardware stores.

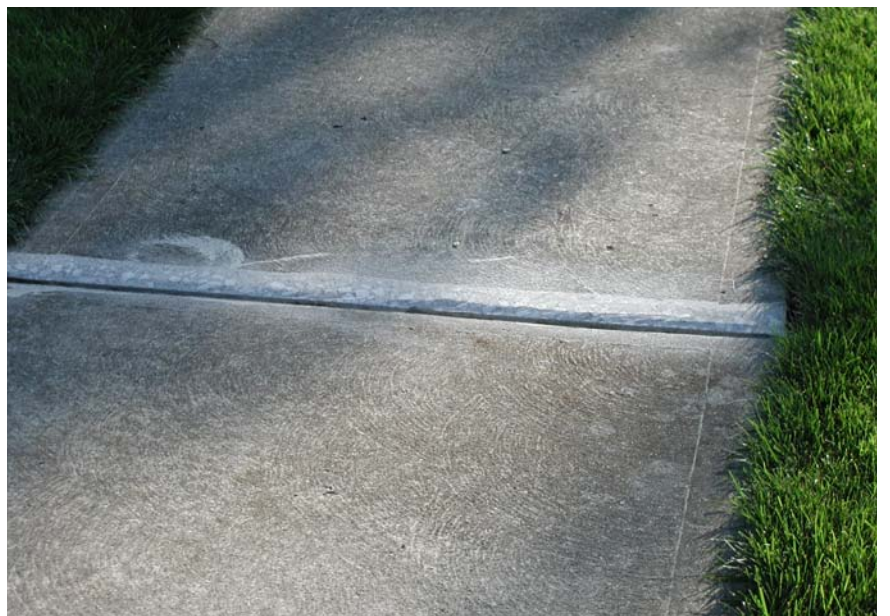
As mentioned earlier, the Ground Aggregate can be seen in the following picture where a 1/2" surface offset was ground to a 1:2 ratio as prescribed in the Access Board for compliance with the Americans With Disabilities Act. The entire Sidewalk can be power washed following the grinding operation in order to match the color of the freshly ground surfaces, although many people find this step to be unnecessary.
